# **Intel<sup>®</sup> Pentium<sup>®</sup> III Processor Specification Update**

Release Date: February 2002

Order Number: 244453-037

The Pentium<sup>®</sup> III processor may contain design defects or errors known as errata which may cause the product to deviate from published specifications. Current characterized errata are documented in this Specification Update.

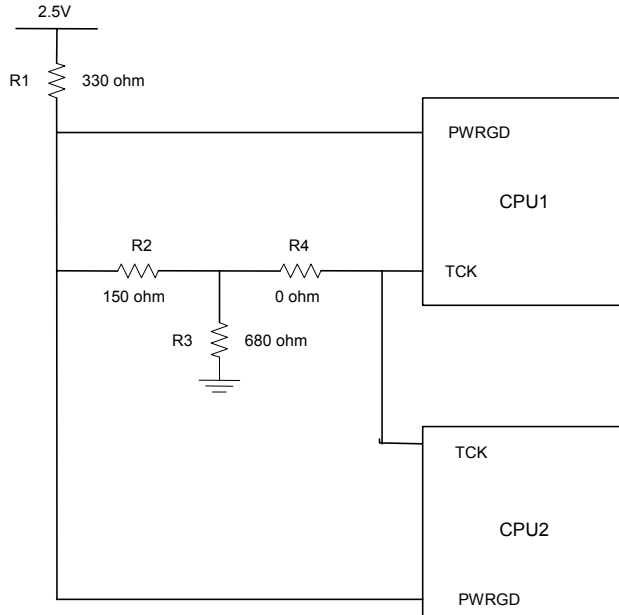
Pentium® III Processor with 512KB L2 Cache Platforms Workaround

Assumes the inputs to the CPU\_PWRGD are open collector signals that are Wire-ANDed together

- The example workaround circuit assumes that the PWRGD inputs into the processors are open collector. Tying the PWRGD inputs together in a Wired-AND fashion allows each processor to receive PWRGD at the same time but at the latter of the 2 separate PWRGD assertions. If separation of the PWRGD inputs to each processor is required, extra circuitry will be required.

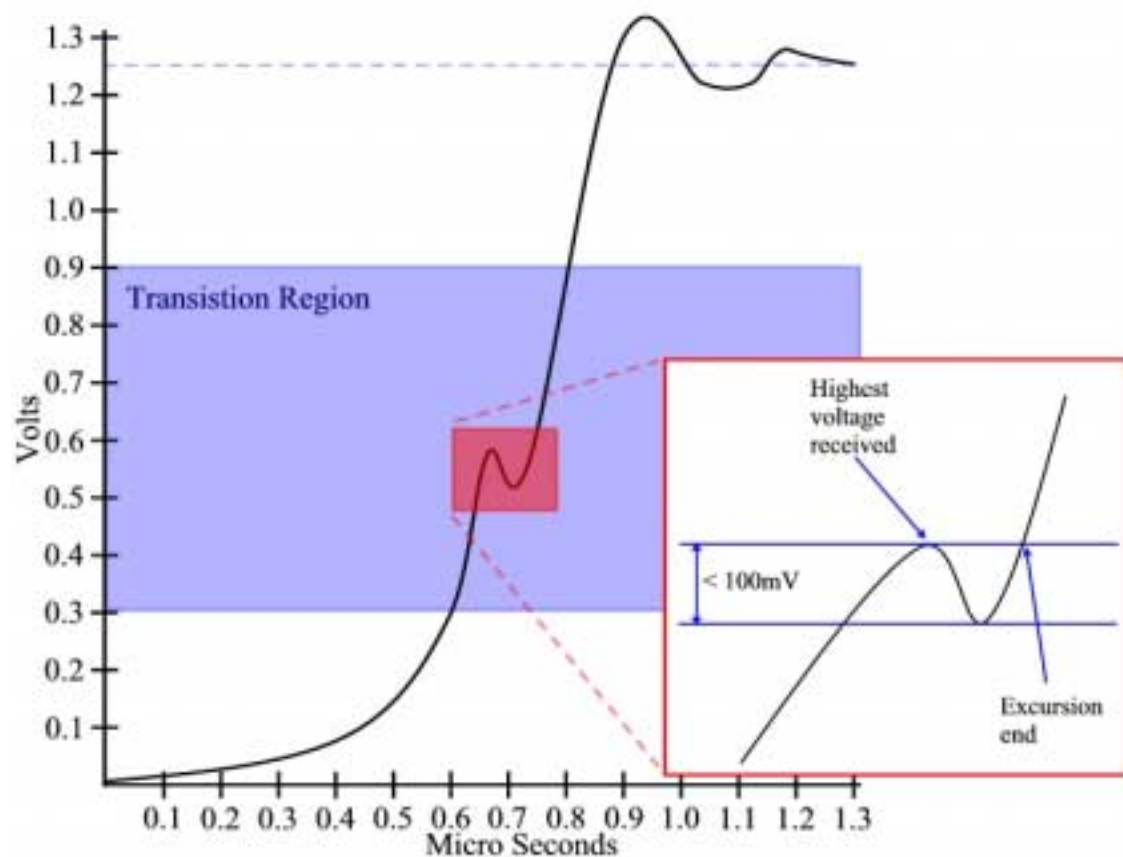
**Figure 1: Noise Estimation**

The signal quality of the VTT\_PWRGD signal is critical to the correct operation of the processor. Every effort should be made to ensure this signal is monotonic in the transition region. If noise or glitches are present on this signal, it must be kept to less than 100mV of a voltage drop from the highest voltage level received to that point. This glitch must remain less than 100mV until the excursion ends by the voltage returning to the highest voltage previously received. Please see Figure 1 for an example graph of this situation and requirements.

This change will be incorporated into the next revision of the Datasheet.
